Manhole Inspection Summary

Manhole # S29GG2008MH

Location Address: **15 LAKE AVE**

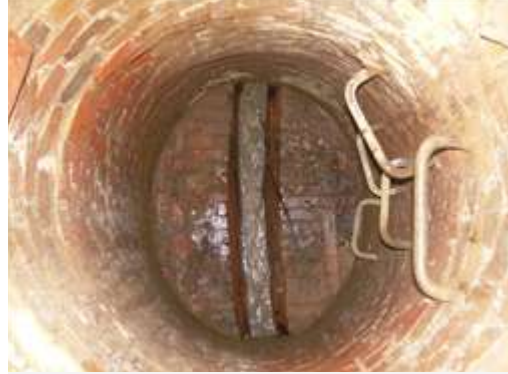
Top View

Evidence of surcharge - Bench debris.

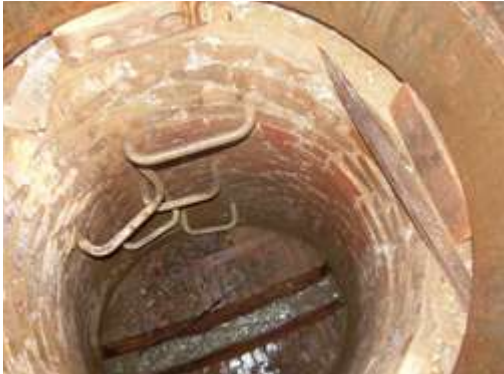
Defect

Frame leak. Adjustment deterioration, loose brick, and infiltration. Corbel infiltration - other side.

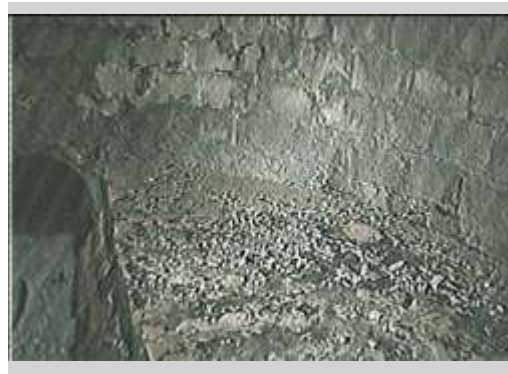
Defect

Barrel deterioration and infiltration.

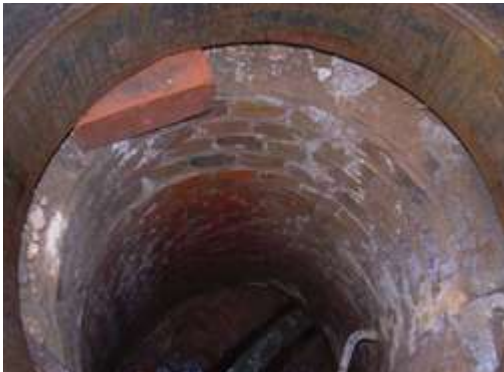
Defect

Adjustment deterioration, loose brick, and infiltration. Corbel infiltration.

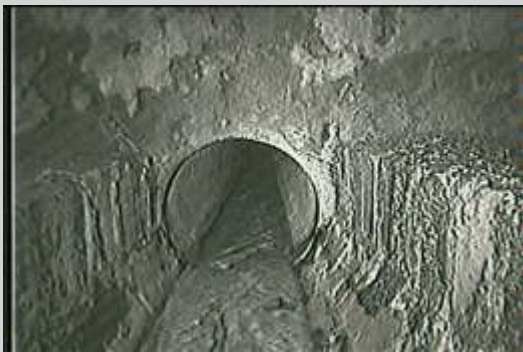
8 in. Circular Gravity Sewer Pipe Out @ 12 O'Clock

Infiltration: **None** Pipe Seal Cond: **Cracked**

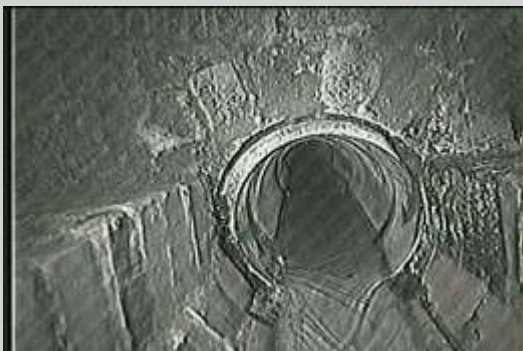
8 in. Circular Gravity Sewer Pipe In @ 6 O'Clock

Infiltration: **Evidence** Pipe Seal Cond: **Unknown**
